## **TAMU Project**

**Energy Consumption Data Quality Assurance/Quality  
Control Assessment Report for the  
Month of March 2016**

**Utility & Energy Services  
Division of Administration  
Texas A&M University**

**April 2016**

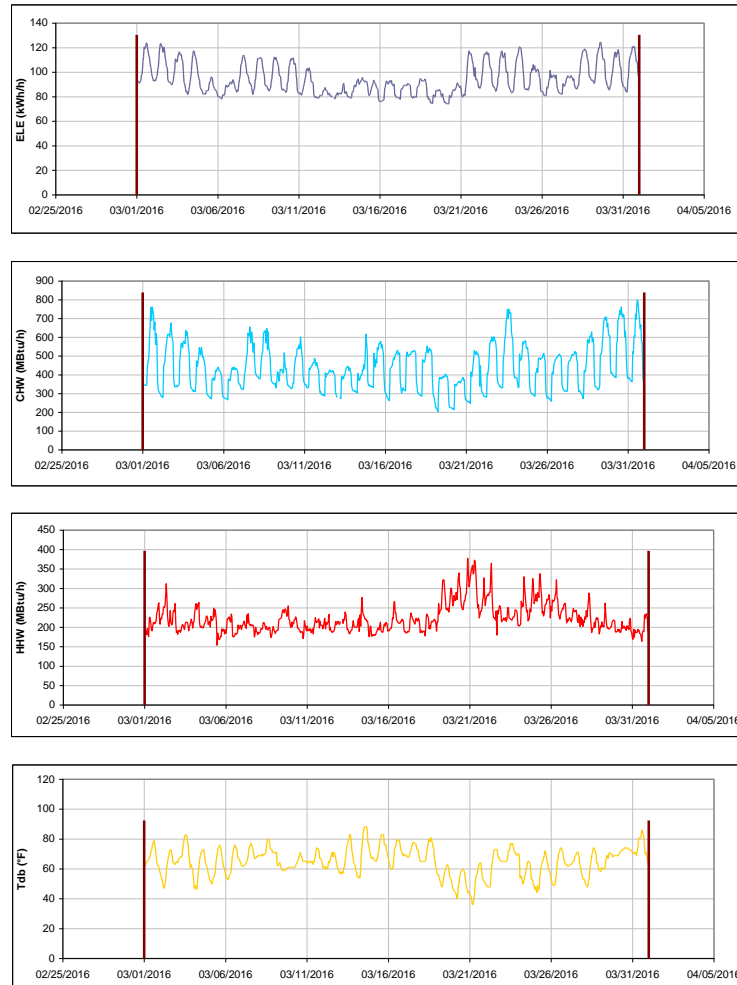
TAMU / BLDG #: 0492

Figure III-95 Hourly Whole Building Electricity, Chilled Water, and Hot Water Consumption for Civil Engineering Building during the Month of March 2016 and the Corresponding Hourly Outdoor Dry Bulb Temperature for College Station, TX

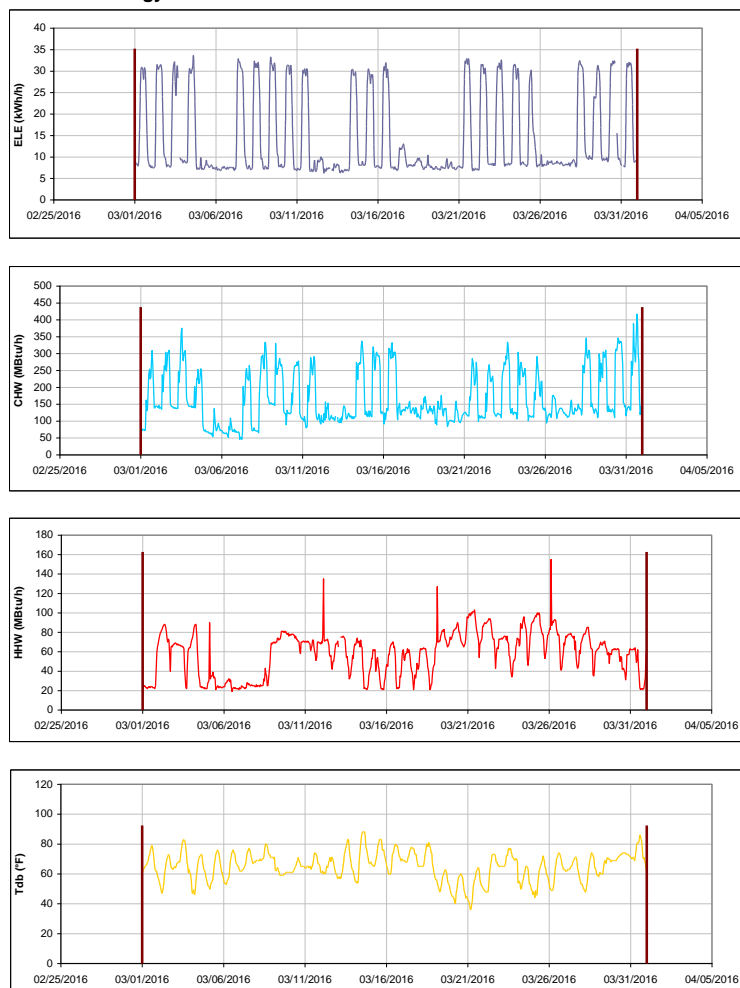
TAMU / BLDG #: 0496

Figure III-97 Hourly Whole Building Electricity, Chilled Water, and Hot Water Consumption for Utilities & Energy Services Central Office during the Month of March 2016 and the Corresponding Hourly Outdoor Dry Bulb Temperature for College Station, TX

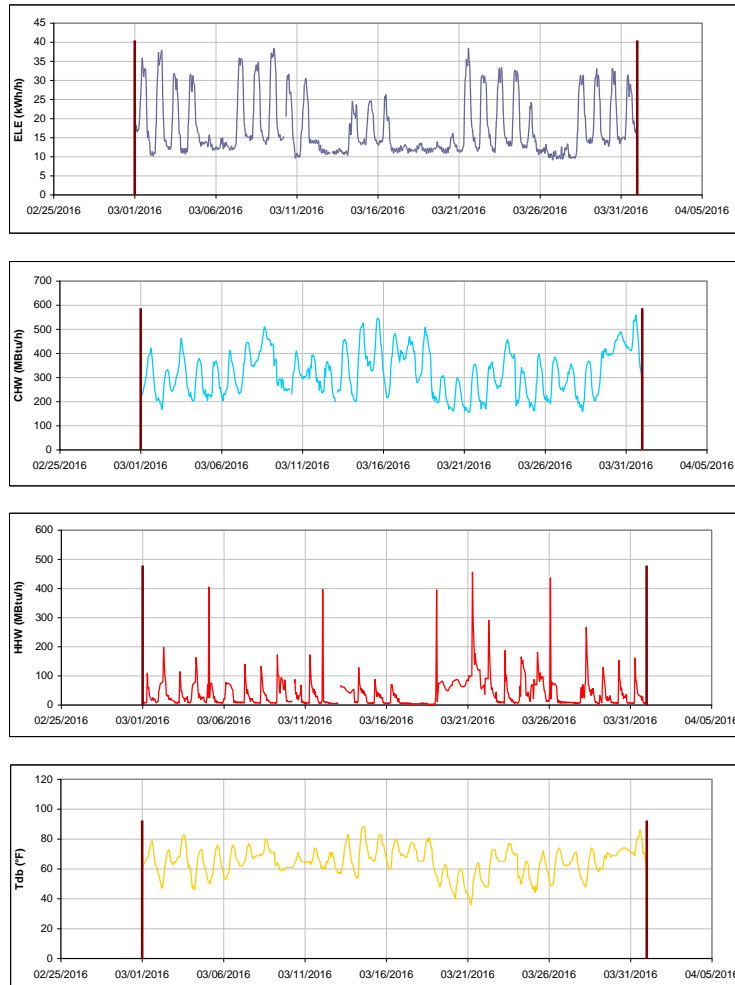
TAMU / BLDG #: 0506

Figure III-99 Hourly Whole Building Electricity, Chilled Water, and Hot Water Consumption for Nagle Hall during the Month of March 2016 and the Corresponding Hourly Outdoor Dry Bulb Temperature for College Station, TX

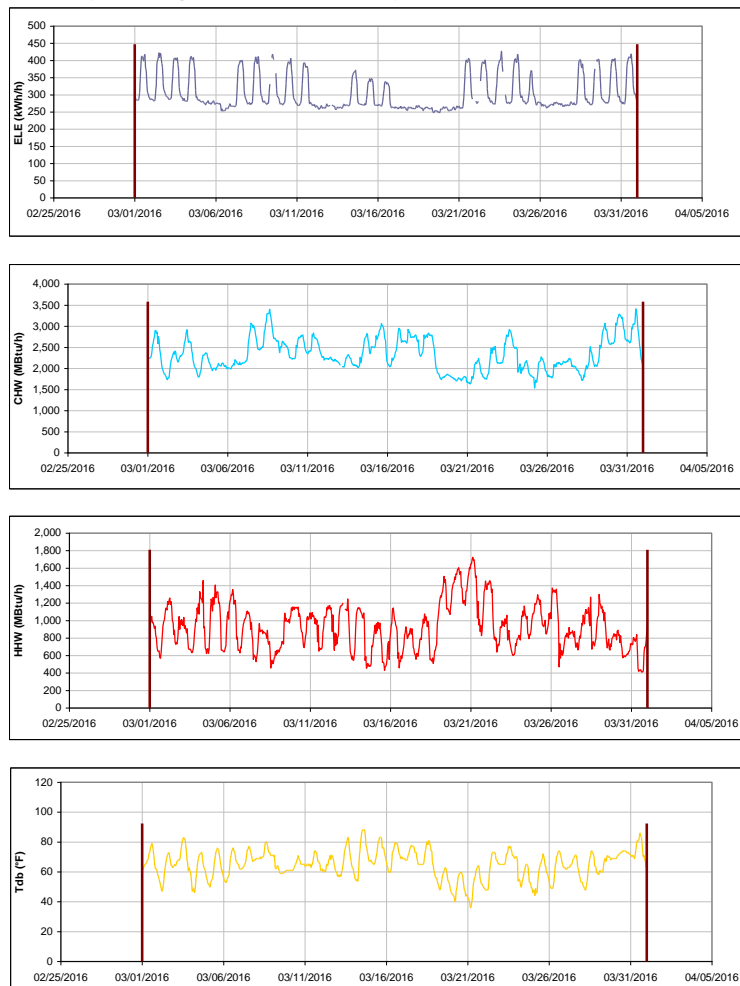
Veterinary Teaching Hospital and Veterinary Medicine Administration / BLDG #: 3508-1026

Figure III-101 Hourly Whole Building Electricity, Chilled Water, and Hot Water Consumption for Veterinary Teaching Hospital and Veterinary Medicine Administration during the Month of March 2016 and the Corresponding Hourly Outdoor Dry Bulb Temperature for College Station, TX

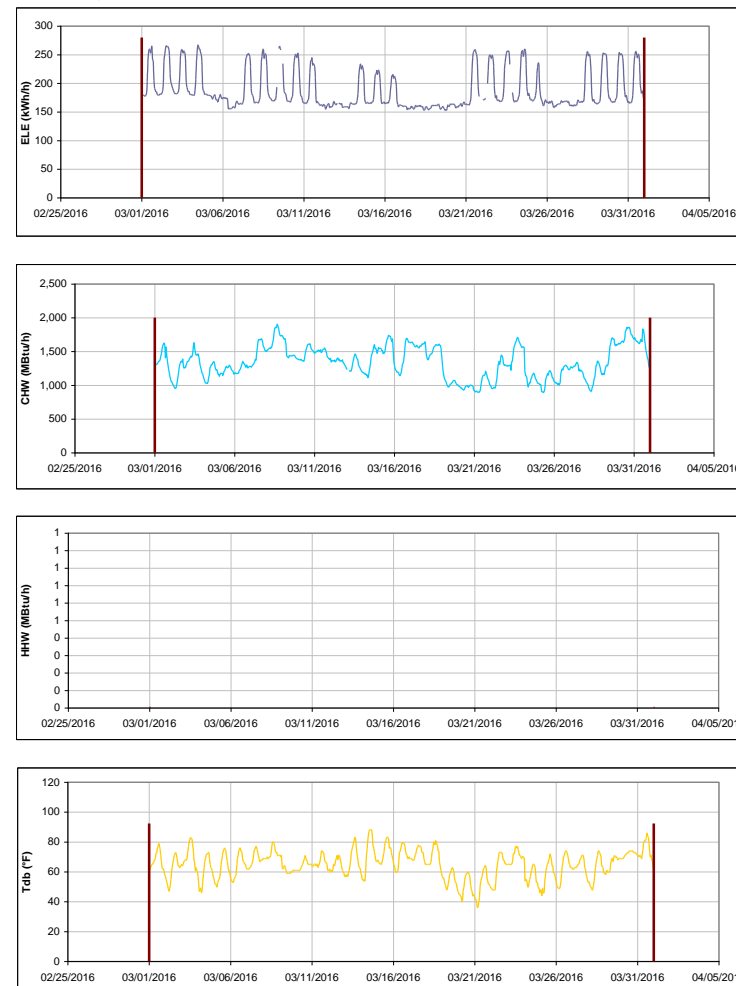
TAMU / BLDG #: 1026

Figure III-102 Hourly Whole Building Electricity, Chilled Water, and Hot Water Consumption for Veterinary Medicine Administration during the Month of March 2016 and the Corresponding Hourly Outdoor Dry Bulb Temperature for College Station, TX

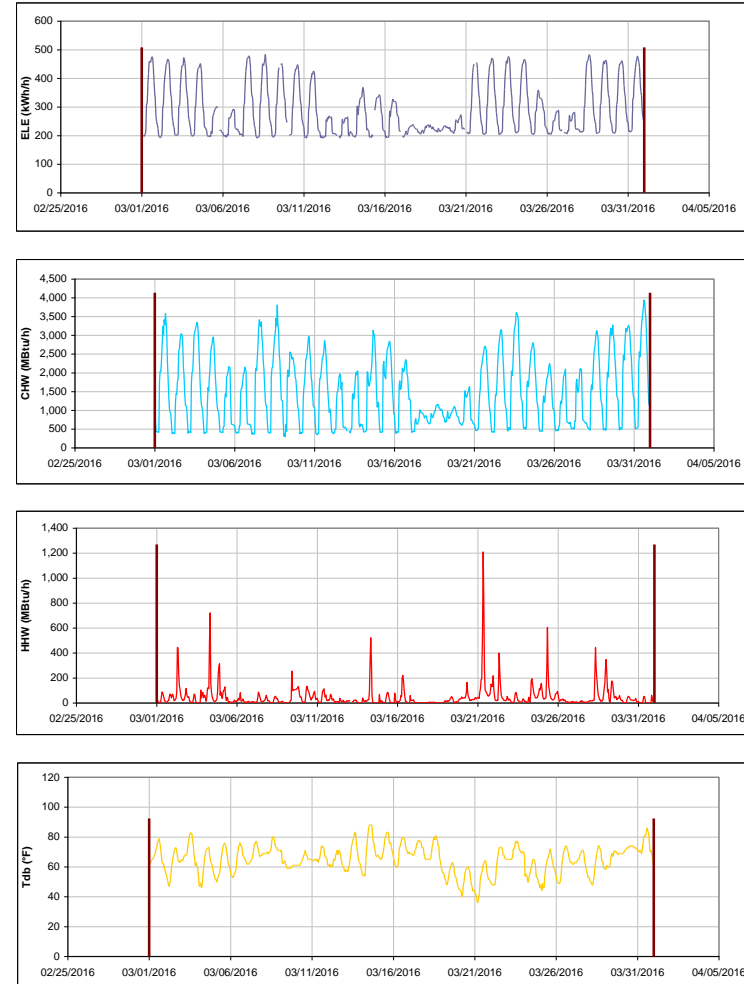
TAMU / BLDG #: 0524

Figure III-110 Hourly Whole Building Electricity, Chilled Water, and Hot Water Consumption for Blocker building during the Month of March 2016 and the Corresponding Hourly Outdoor Dry Bulb Temperature for College Station, TX

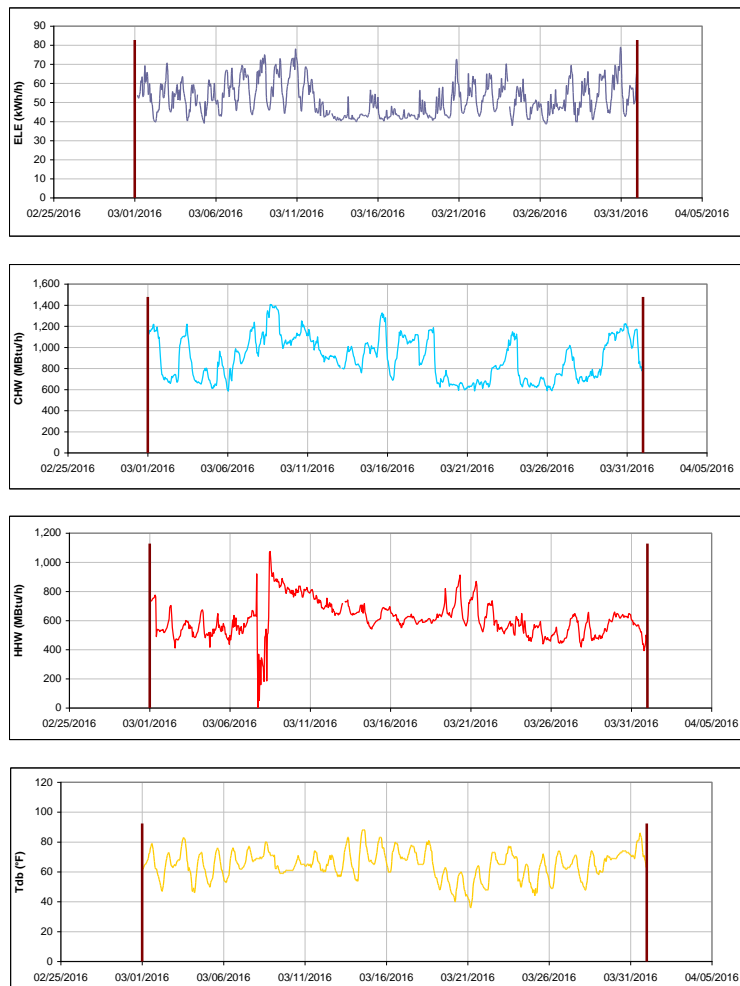
TAMU / BLDG #: 0550

Figure III-113 Hourly Whole Building Electricity, Chilled Water, and Hot Water Consumption for McFadden Residence Hall during the Month of March 2016 and the Corresponding Hourly Outdoor Dry Bulb Temperature for College Station, TX

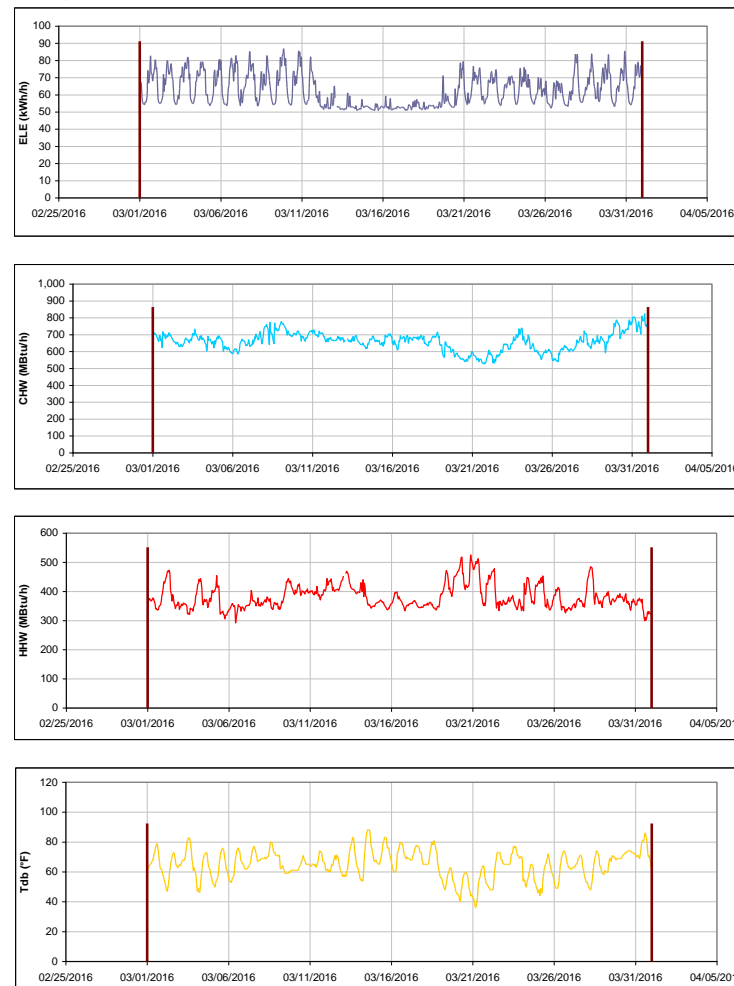
TAMU / BLDG #: 0652

Figure III-114 Hourly Whole Building Electricity, Chilled Water, and Hot Water Consumption for Neeley Residence Hall during the Month of March 2016 and the Corresponding Hourly Outdoor Dry Bulb Temperature for College Station, TX

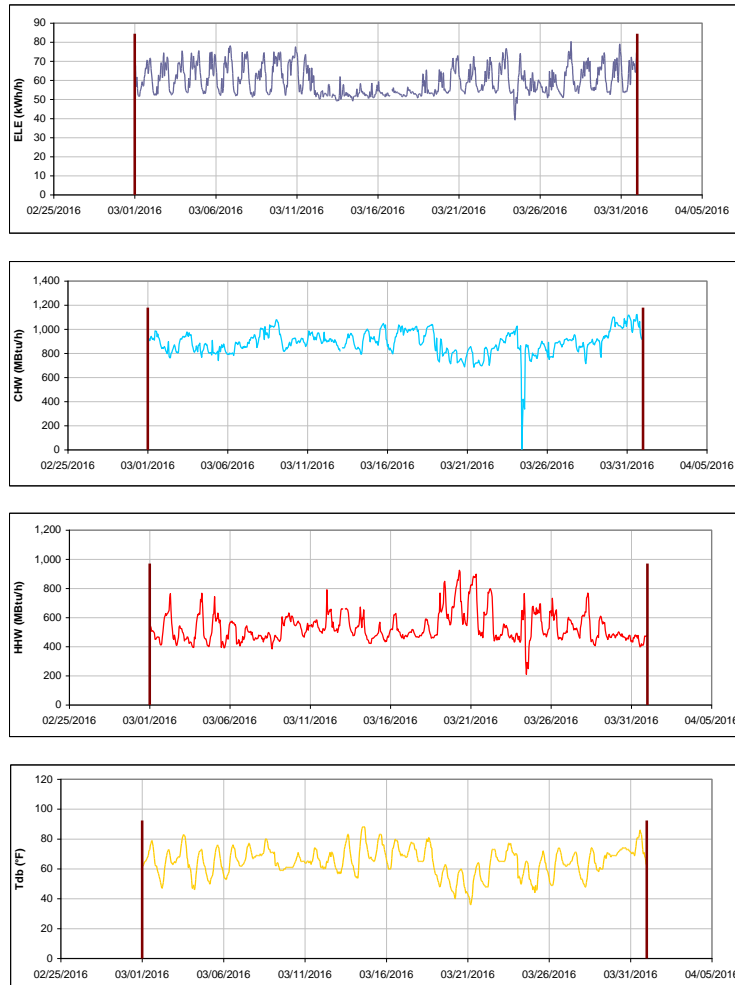
TAMU / BLDG #: 0653

Figure III-115 Hourly Whole Building Electricity, Chilled Water, and Hot Water Consumption for Hobby Residence Hall during the Month of March 2016 and the Corresponding Hourly Outdoor Dry Bulb Temperature for College Station, TX

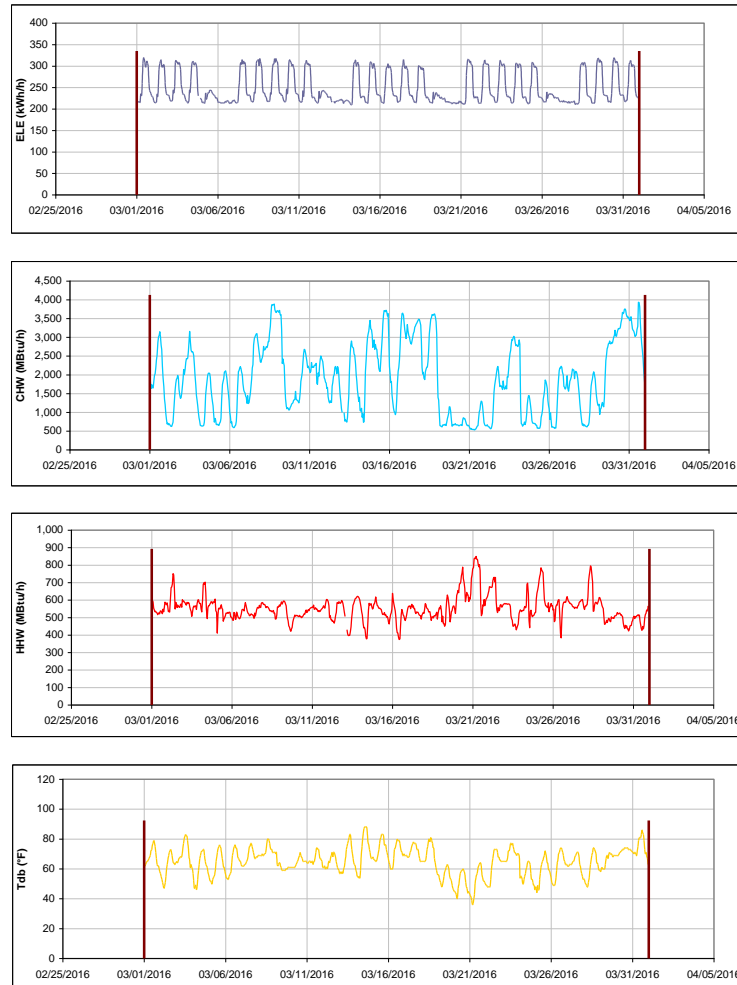
TAMU / BLDG #: 1041

Figure III-123 Hourly Whole Building Electricity, Chilled Water, and Hot Water Consumption for Texas Vet Med Diagnostic Lab during the Month of March 2016 and the Corresponding Hourly Outdoor Dry Bulb Temperature for College Station, TX

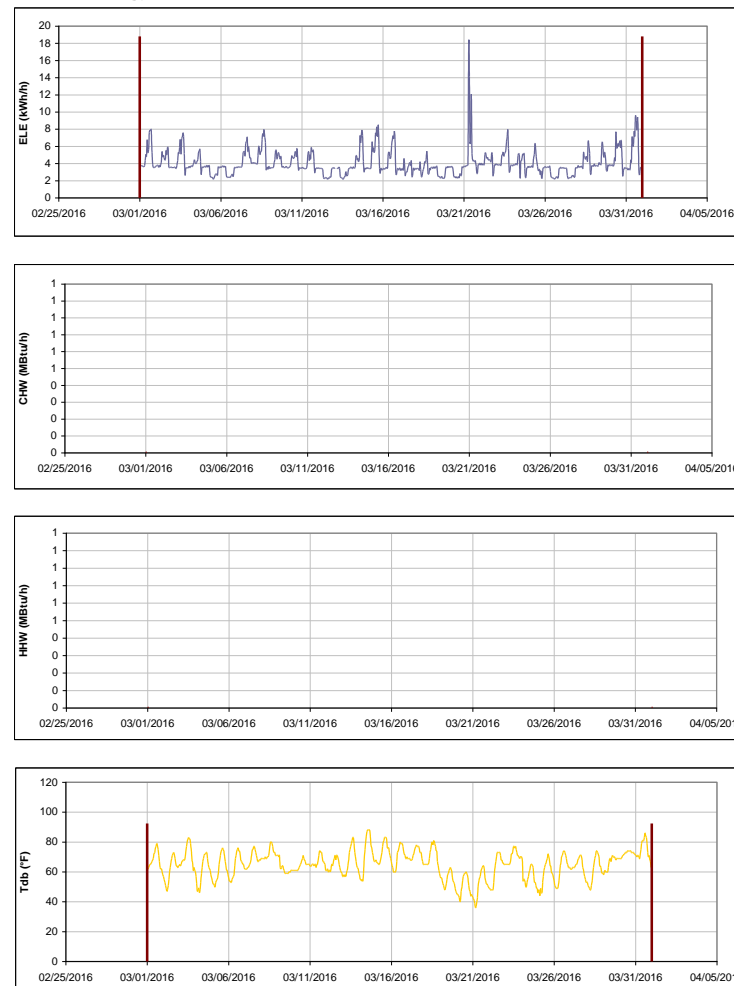
TAMU / BLDG #: 1089

Figure III-126 Hourly Whole Building Electricity, Chilled Water, and Hot Water Consumption for Utilities Energy Office Annex during the Month of March 2016 and the Corresponding Hourly Outdoor Dry Bulb Temperature for College Station, TX

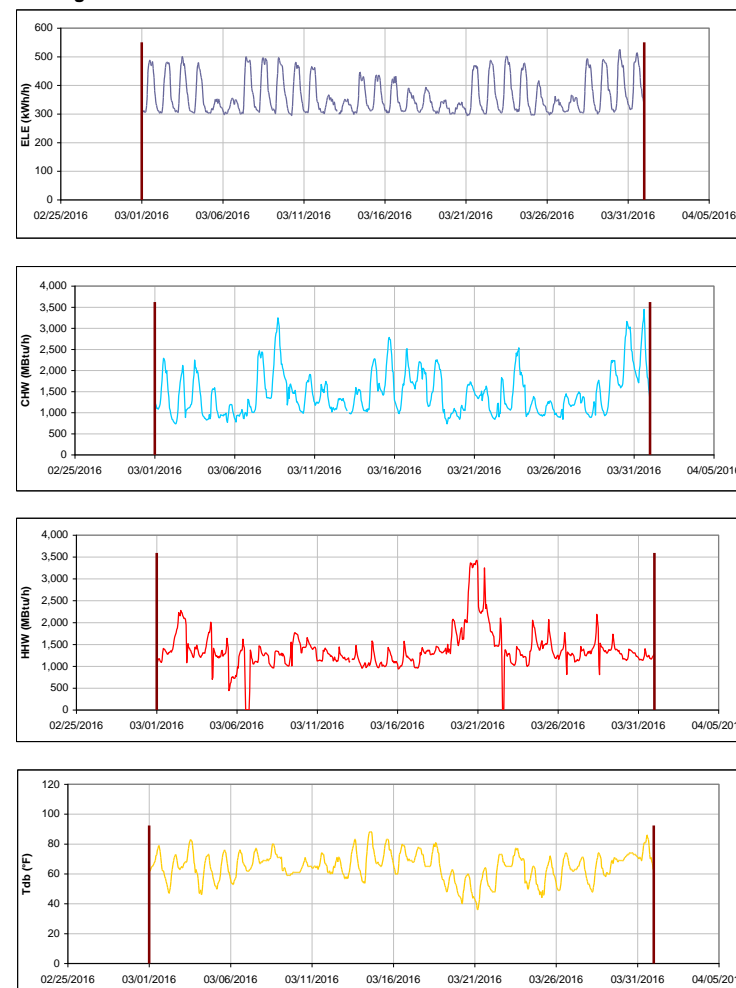
TAMU / BLDG #: 1501

Figure III-144 Hourly Whole Building Electricity, Chilled Water, and Hot Water Consumption for Kleberg Center during the Month of March 2016 and the Corresponding Hourly Outdoor Dry Bulb Temperature for College Station, TX

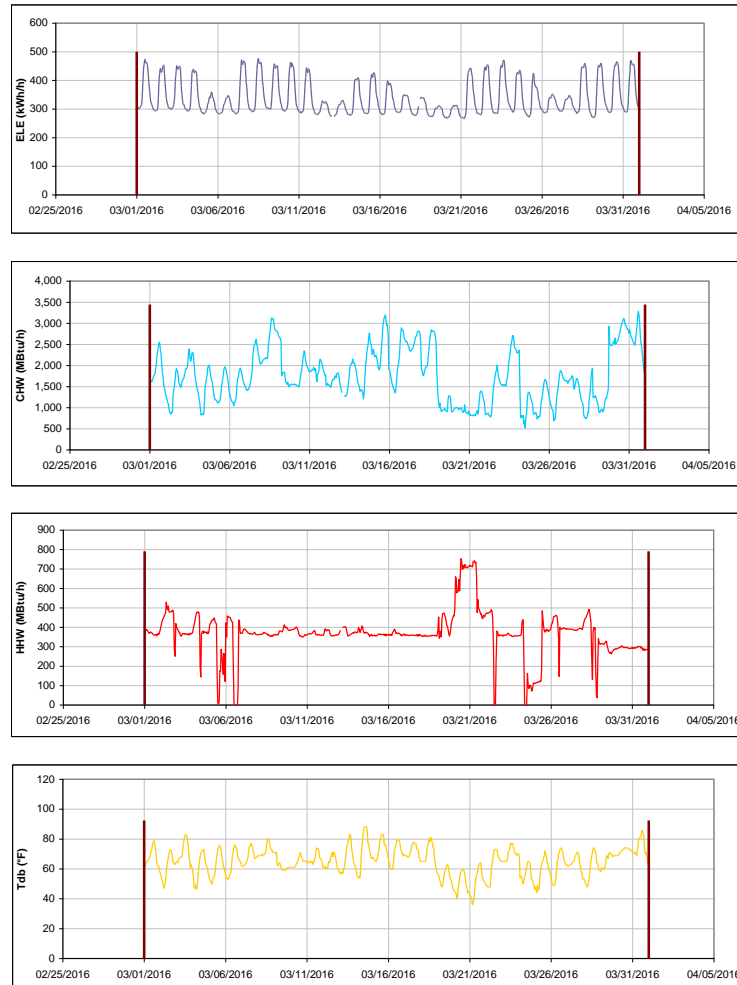
TAMU / BLDG #: 1502

Figure III-145 Hourly Whole Building Electricity, Chilled Water, and Hot Water Consumption for Heep Center during the Month of March 2016 and the Corresponding Hourly Outdoor Dry Bulb Temperature for College Station, TX

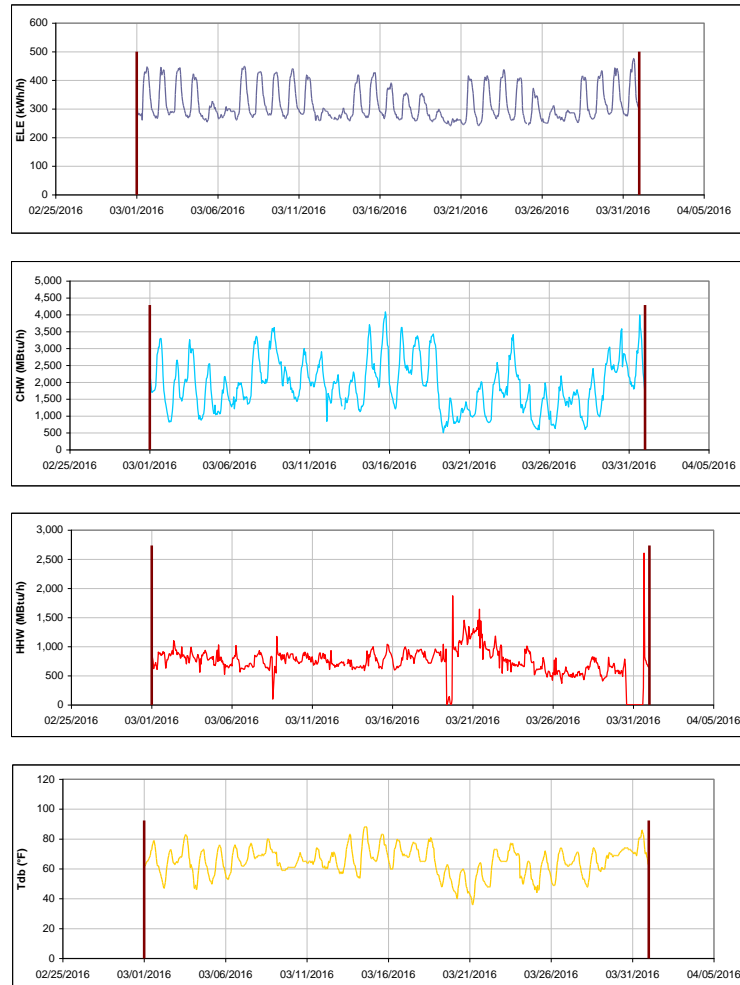
TAMU / BLDG #: 1504

Figure III-147 Hourly Whole Building Electricity, Chilled Water, and Hot Water Consumption for Reynolds Medical Sciences Building during the Month of March 2016 and the Corresponding Hourly Outdoor Dry Bulb Temperature for College Station, TX

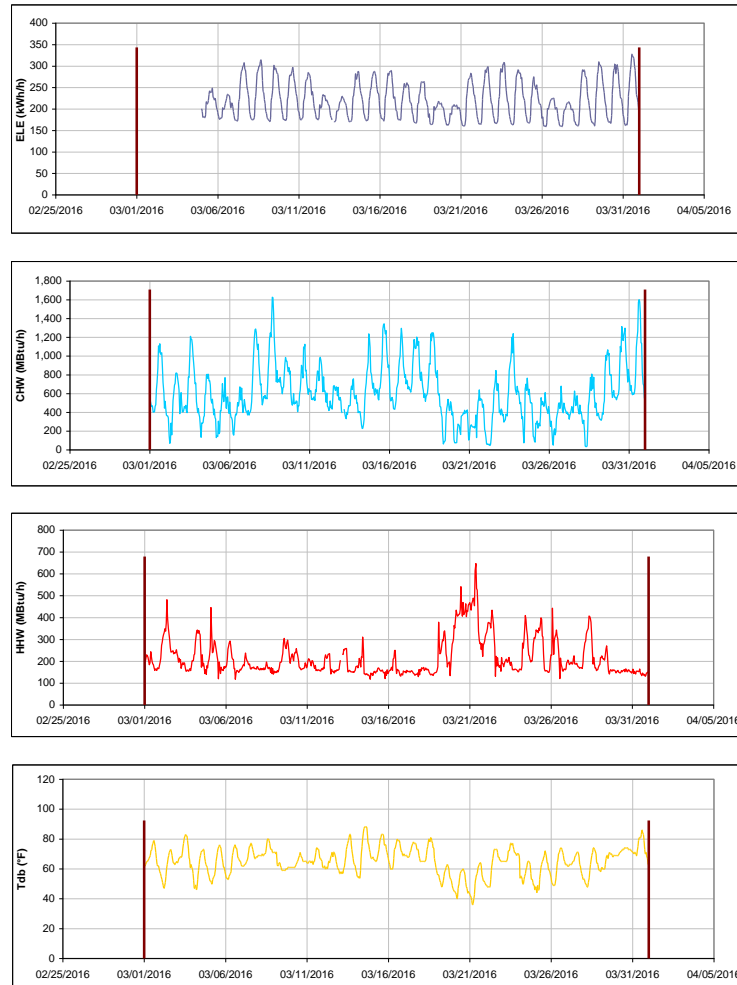
TAMU / BLDG #: 1506

Figure III-149 Hourly Whole Building Electricity, Chilled Water, and Hot Water Consumption for Horticulture-Forest Science Building during the Month of March 2016 and the Corresponding Hourly Outdoor Dry Bulb Temperature for College Station, TX

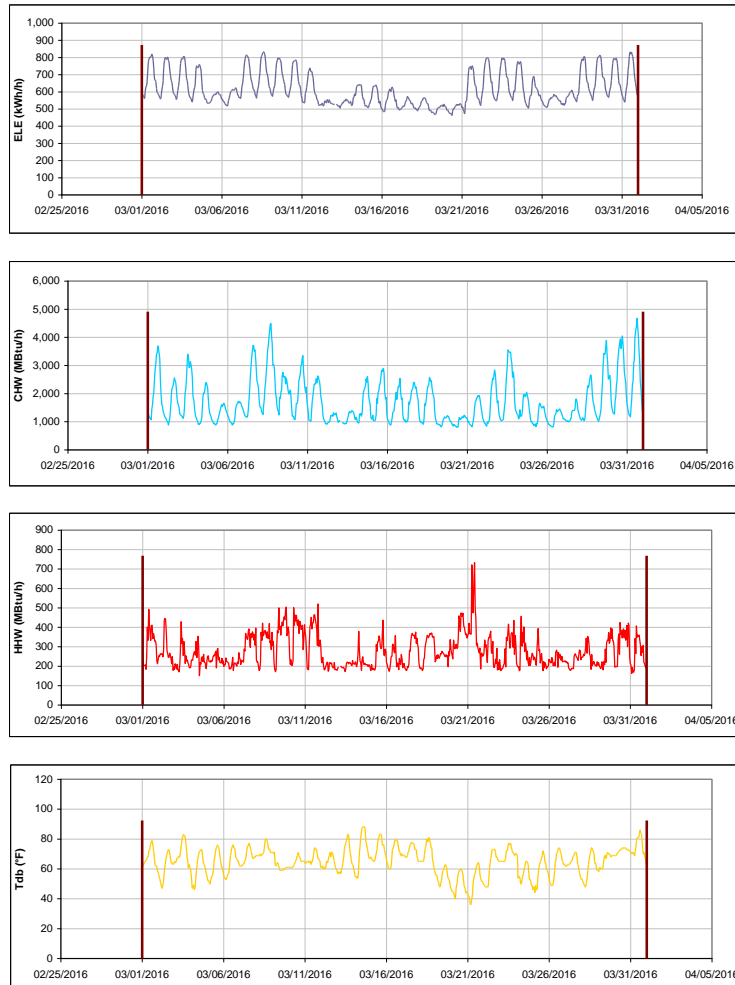
TAMU / BLDG #: 1510

Figure III-153 Hourly Whole Building Electricity, Chilled Water, and Hot Water Consumption for Wehner Building during the Month of March 2016 and the Corresponding Hourly Outdoor Dry Bulb Temperature for College Station, TX

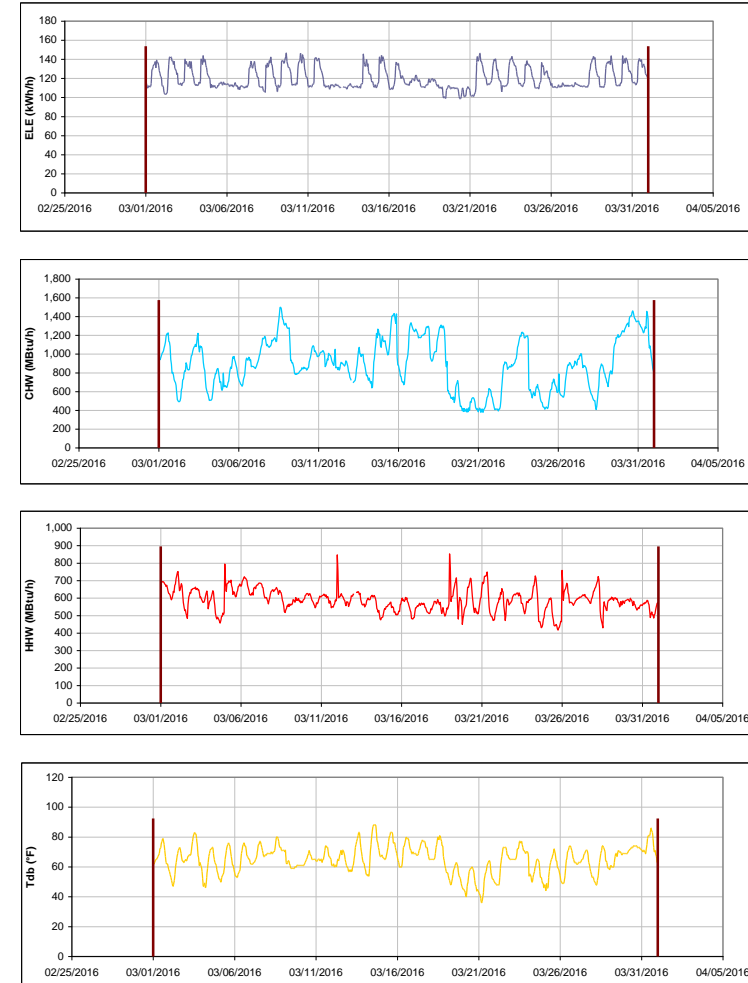
TAMU / BLDG #: 1525

Figure III-158 Hourly Whole Building Electricity, Chilled Water, and Hot Water Consumption for Nuclear Magnetic Resonance Facility during the Month of March 2016 and the Corresponding Hourly Outdoor Dry Bulb Temperature for College Station, TX

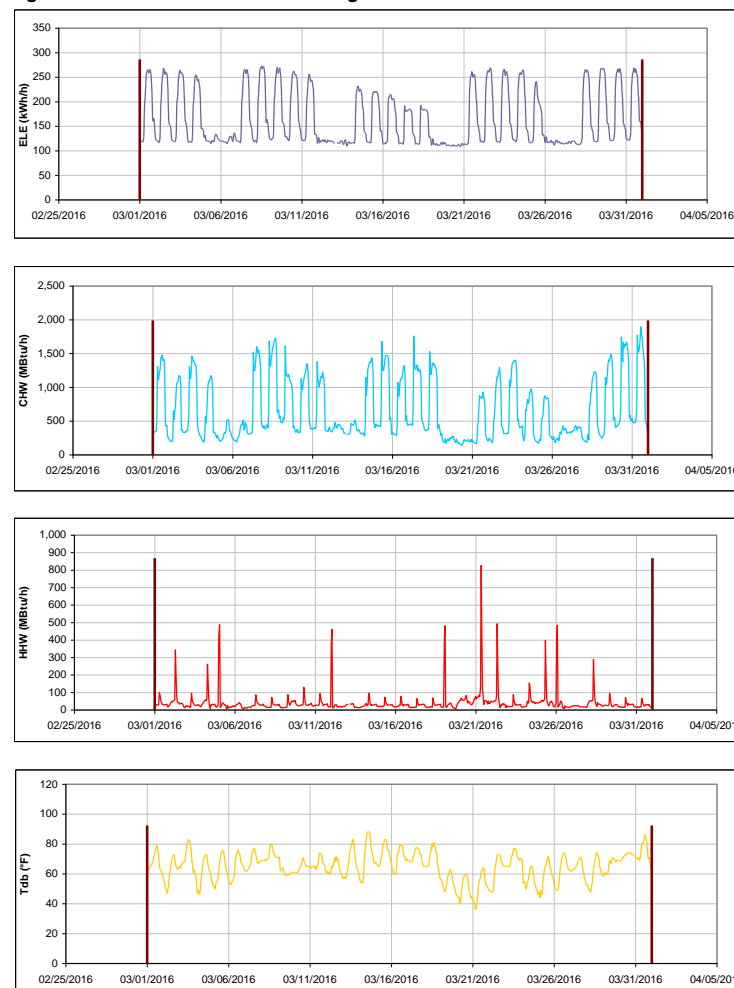
TAMU / BLDG #: 1535

Figure III-160 Hourly Whole Building Electricity, Chilled Water, and Hot Water Consumption for Agriculture and Life Sciences Building during the Month of March 2016 and the Corresponding Hourly Outdoor Dry Bulb Temperature for College Station, TX

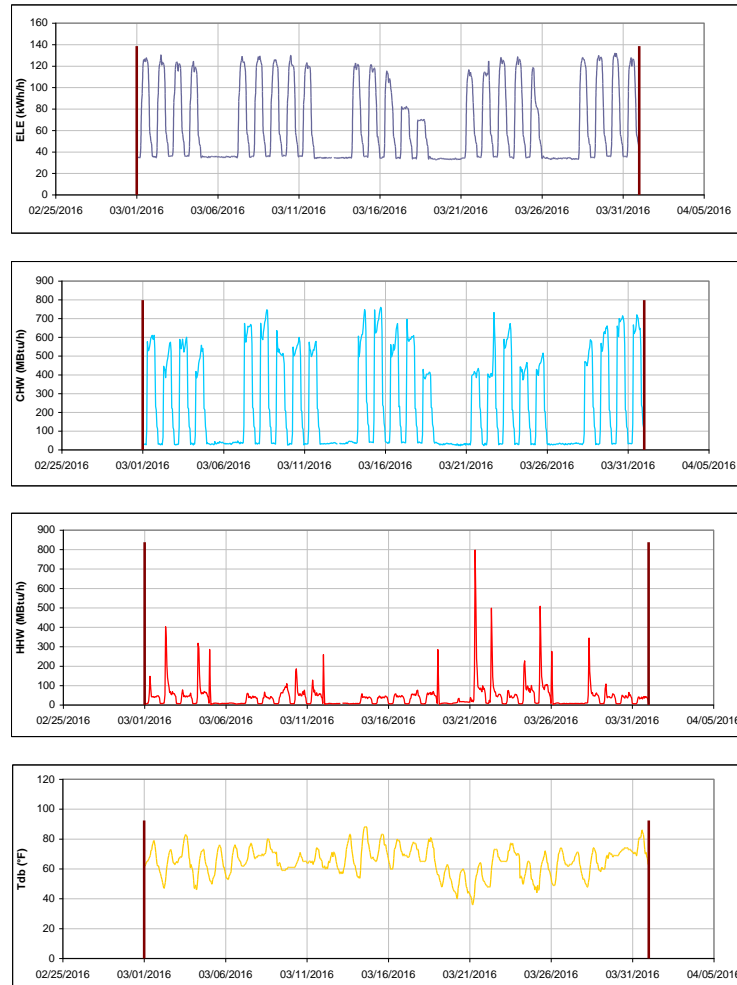
TAMU / BLDG #: 1536

Figure III-161 Hourly Whole Building Electricity, Chilled Water, and Hot Water Consumption for AgriLife Services Building during the Month of March 2016 and the Corresponding Hourly Outdoor Dry Bulb Temperature for College Station, TX

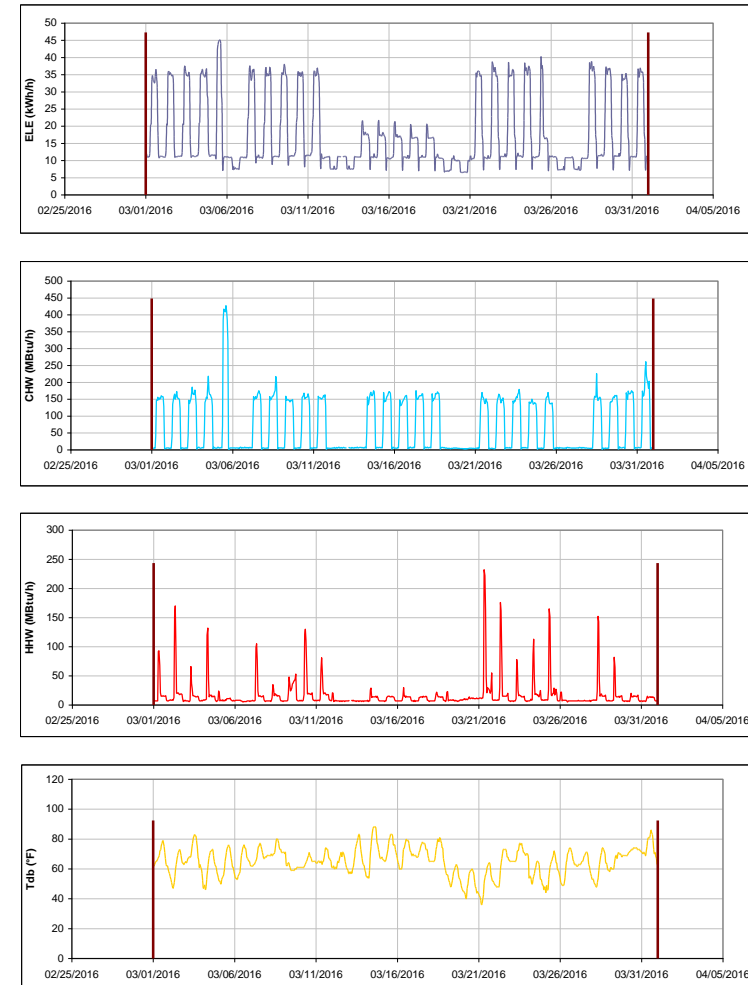
TAMU / BLDG #: 1538

Figure III-162 Hourly Whole Building Electricity, Chilled Water, and Hot Water Consumption for Agriculture Program Visitors Center during the Month of March 2016 and the Corresponding Hourly Outdoor Dry Bulb Temperature for College Station, TX

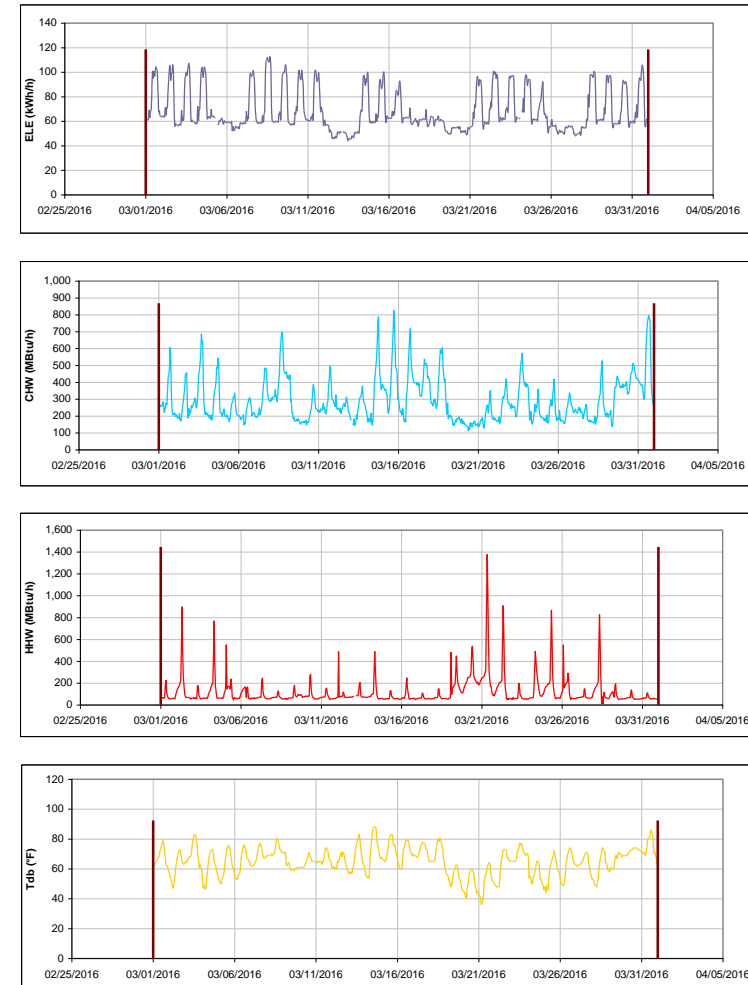
TAMU / BLDG #: 1600

Figure III-172 Hourly Whole Building Electricity, Chilled Water, and Hot Water Consumption for Gilchrist TTI Building during the Month of March 2016 and the Corresponding Hourly Outdoor Dry Bulb Temperature for College Station, TX

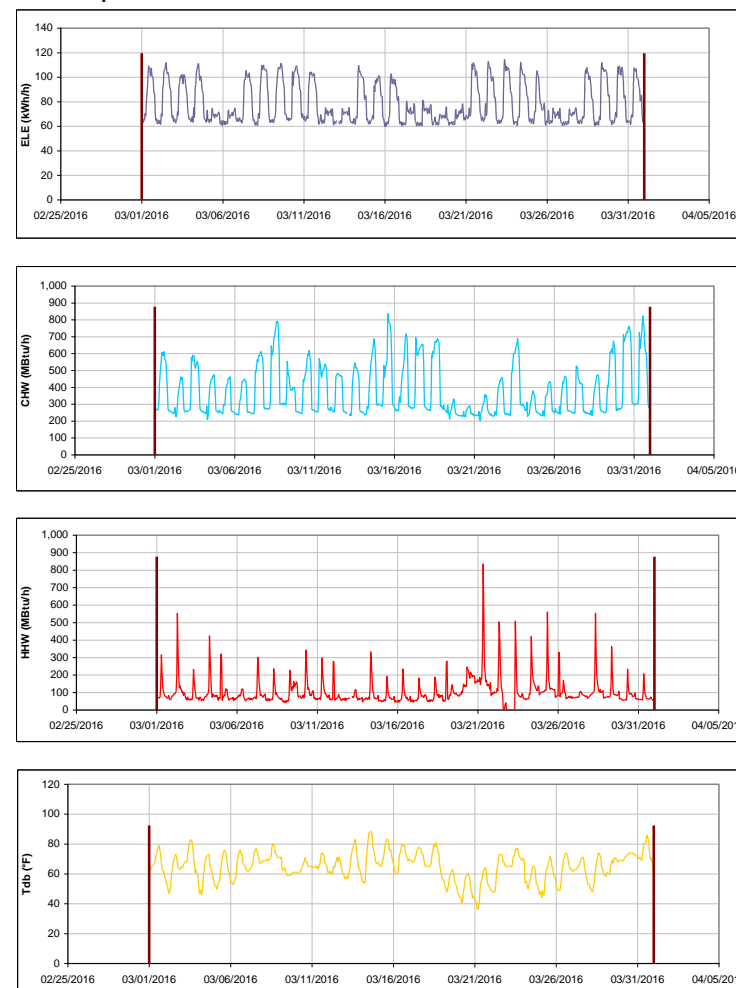
TAMU / BLDG #: 1609

Figure III-178 Hourly Whole Building Electricity, Chilled Water, and Hot Water Consumption for TTI Headquarters during the Month of March 2016 and the Corresponding Hourly Outdoor Dry Bulb Temperature for College Station, TX

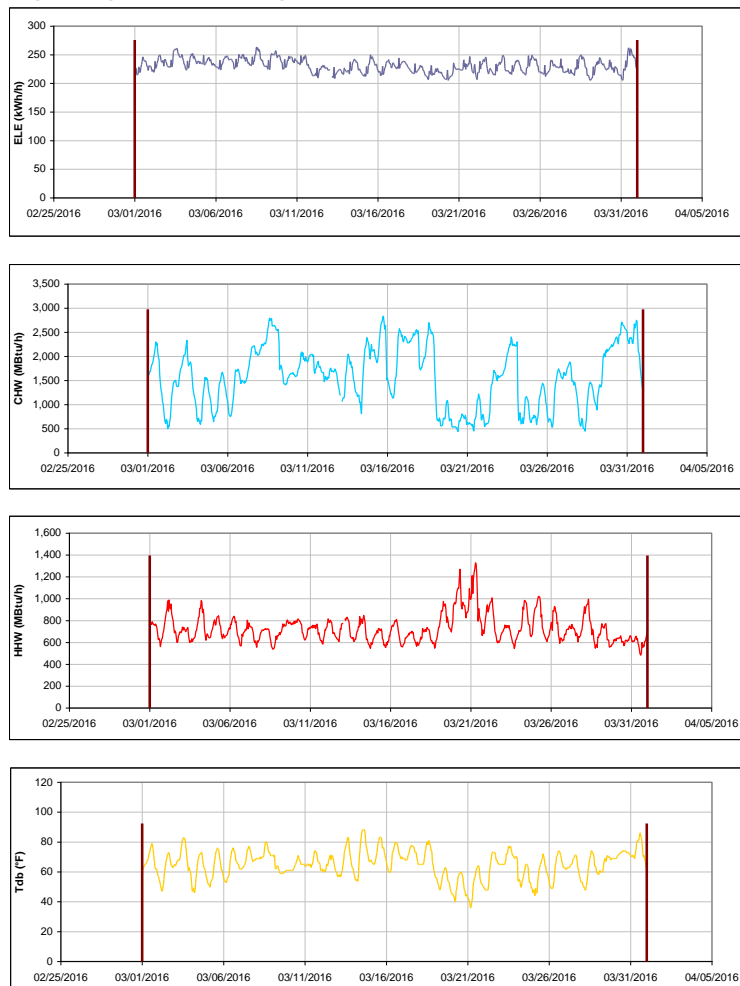
TAMU / BLDG #: 1611

Figure III-179 Hourly Whole Building Electricity, Chilled Water, and Hot Water Consumption for Engineering Research Building during the Month of March 2016 and the Corresponding Hourly Outdoor Dry Bulb Temperature for College Station, TX

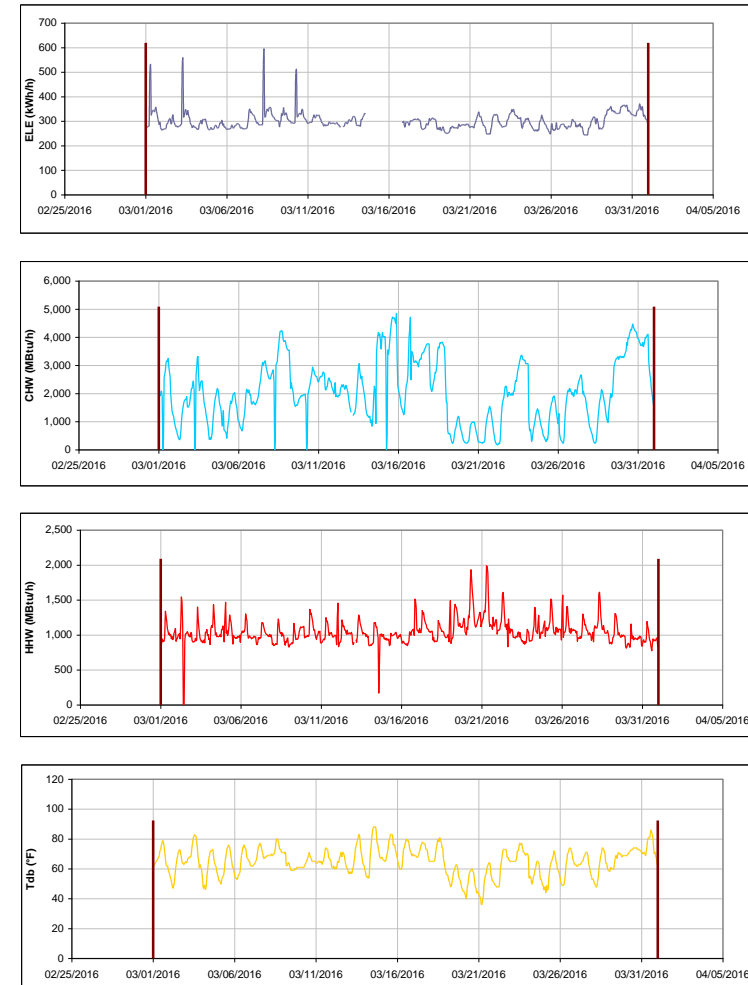
TAMU / BLDG #: 1904

Figure III-184 Hourly Whole Building Electricity, Chilled Water, and Hot Water Consumption for Texas A&M Institute for Preclinical Studies A during the Month of March 2016 and the Corresponding Hourly Outdoor Dry Bulb Temperature for College Station, TX
